Manhole Inspection Summary

Manhole # S17CC_033MH

Location Address: **1139 BENTALOU-PAYSON**

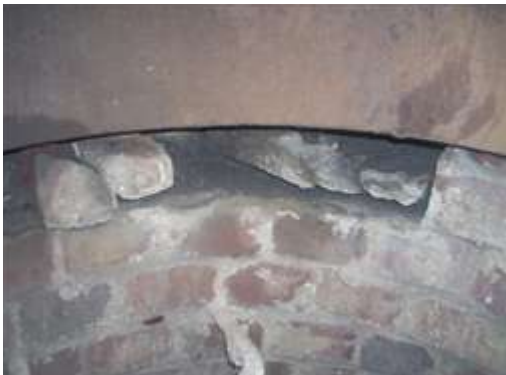
Defect 2

Condition: ☐ Sound ☐ Cracked ☐ Root Intrusion ☐ Loose Brick ☒ **Deteriorated**

DETERIORATED CORBEL

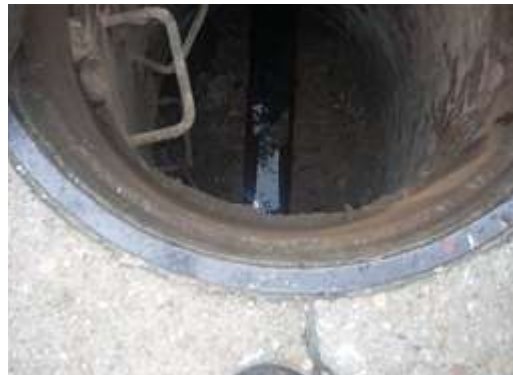
Defect 1

Frame Offset: **0.5** (in.) Condition: ☒ Sound ☐ Cracked ☐ Leaks

FRAME OFFSET

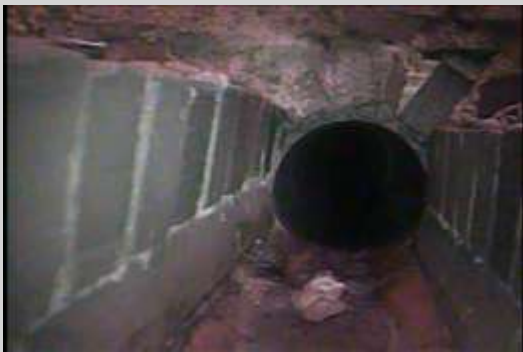
12 O'Clock Outflow

8 in. Circular Gravity Sewer
Pipe Out @ 12 O'Clock

Pipe Height: **7.2** (in.) Rod and Bar (Angled)
Pipe Material: **Clay** ☐ Pipe Lined
Invert Depth: **6.82** (ft.) Flow Characteristics: **Slow**
Deposits: ☒ None ☐ Mud ☐ Sludge ☐ Debris ☐ Grease
Silt Depth: (in.) Deposits Extent:
Infiltration: **None** Pipe Seal Cond: **Sound**

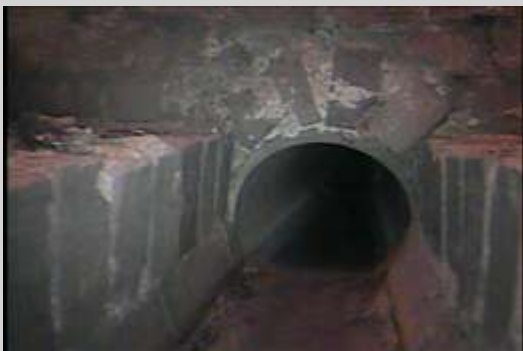
6 O'Clock Inflow

8 in. Circular Gravity Sewer
Pipe In @ 6 O'Clock

Pipe Height: **7.2** (in.) Rod and Bar (Angled)
Pipe Material: **Clay** ☐ Pipe Lined
Invert Depth: **6.62** (ft.) Flow Characteristics: **Slow**
Deposits: ☒ None ☐ Mud ☐ Sludge ☐ Debris ☐ Grease
Silt Depth: (in.) Deposits Extent:
Infiltration: **None** Pipe Seal Cond: **Sound**
